Appendix E: Southern Region Circuit F365

Southern Region Circuit F365 (Page J-67 of ComEd's 2002 Reliability Report):

Field Notes and Pictures

Feeder Ckt/Sub: F365/DCF 36 (Goodenow) City: Beecher, Crete, Crete Twp, Goodenow, Steger, Washington Twp Voltage: 12kV Date: Thursday, June 19, 2003

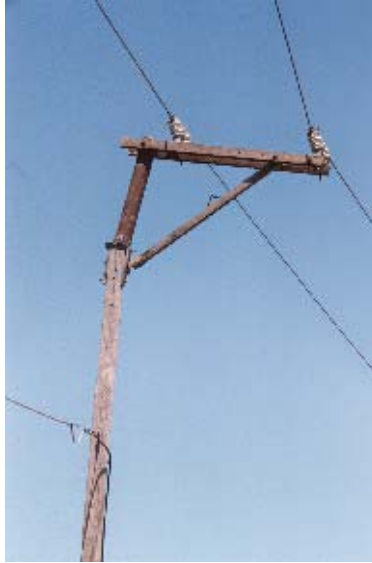
Picture E-1

Photo ID	Drawing No.	Location Description	Observations at this Location
E1	F365-4	Northwest corner of Intersection of Highway 394 and Burville Rd.	Pole Extension mounted on top of pole --- Bottom bolt is lose
	F365-4	2nd pole from the Northwest Corner of Intersection of Highway 394 & Burville Rd.	Blown Lightning Arrestor
	F365-4	"	Shell Rotted Pole
E2	F365-4	Pole mounted Transformer feeding Jobbes Cycle Works - -- 1249 E. Burville Rd.	Lightning Arrestor Completely Blown Away
	F365-4	On Burville Rd. 2 poles East of Transformer T17012	Shell Rotted and Lose Pole Top
E3	F365-4	ROW behind 715 Lovella St.	Shell Rotted Pole & Pole is extremely bowed
	F365-4	356 Burville Rd.	Blown Lightning Arrestor
E4	F365-5	27025 Woodlawn Ave	Slack Span into Tree
	F365-5	"	Dead Ended into Pin mounted insulators --- thus the need for a slack span
E5	F365-13	26020 Stony Island	Branch into Transformer
	F365-2	Primary between Fuses 3321 and 3333	White Pine trees have been planted directly under entire section of Primary between these fuse locations
